Product Change Notification / SYST-01SUTS663

ERRATA - PIC18F27/47/57Q84 Silicon Errata and Data Sheet Clarifications

PIC18F27/47/57Q84 Silicon Errata and Data Sheet Clarifications

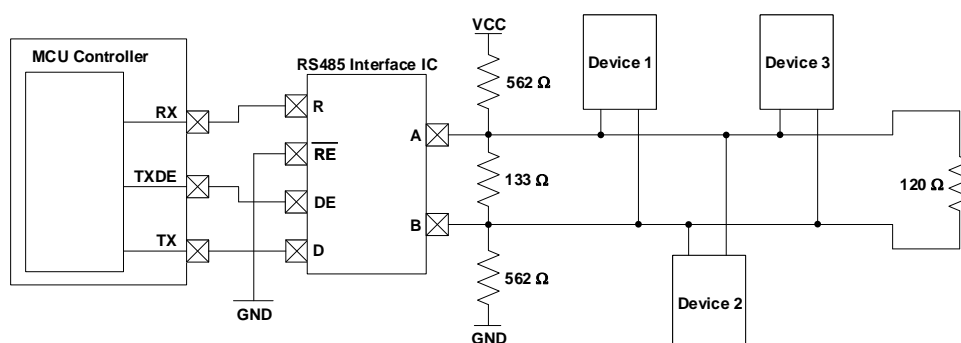
1.6.1 UART TXDE Signal May Go Low Before the STOP Bit Has Been Entirely Transmitted

The UART Transmit Drive Enable (TXDE) signal could potentially transition into a low state before the UART STOP bit has been entirely transmitted due to the effects of parasitic capacitance on the TX line. In some applications, this could result in communication being prematurely terminated due to the TXDE bit going low before the STOP bit has had enough time to settle.

To ensure that the STOP bit settles into its final logic state before the TXDE signal transitions low, a biasing circuit can be implemented. A biasing circuit allows the TX line to either be driven high or low, rather than being left in a floating tri-state mode where prolonged rise or fall times could lead to communication being disrupted. This bias circuit should only be implemented on one end of the serial bus, and a termination resistor should be used on the other end. The figure below show an example of a bias circuit that can be used to achieve this.

Please note that the resistor values used in this circuit are recommendations, and that the actual resistor values required may vary based on the application.
