## Product Change Notification / SYST-27XBYV713

ERRATA - dsPIC33EPXXXGM3XX/6XX/7XX Errata Document Revision

## dsPIC33EPXXXGM3XX/6XX/7XX Family Silicon Errata and Data Sheet Clarification

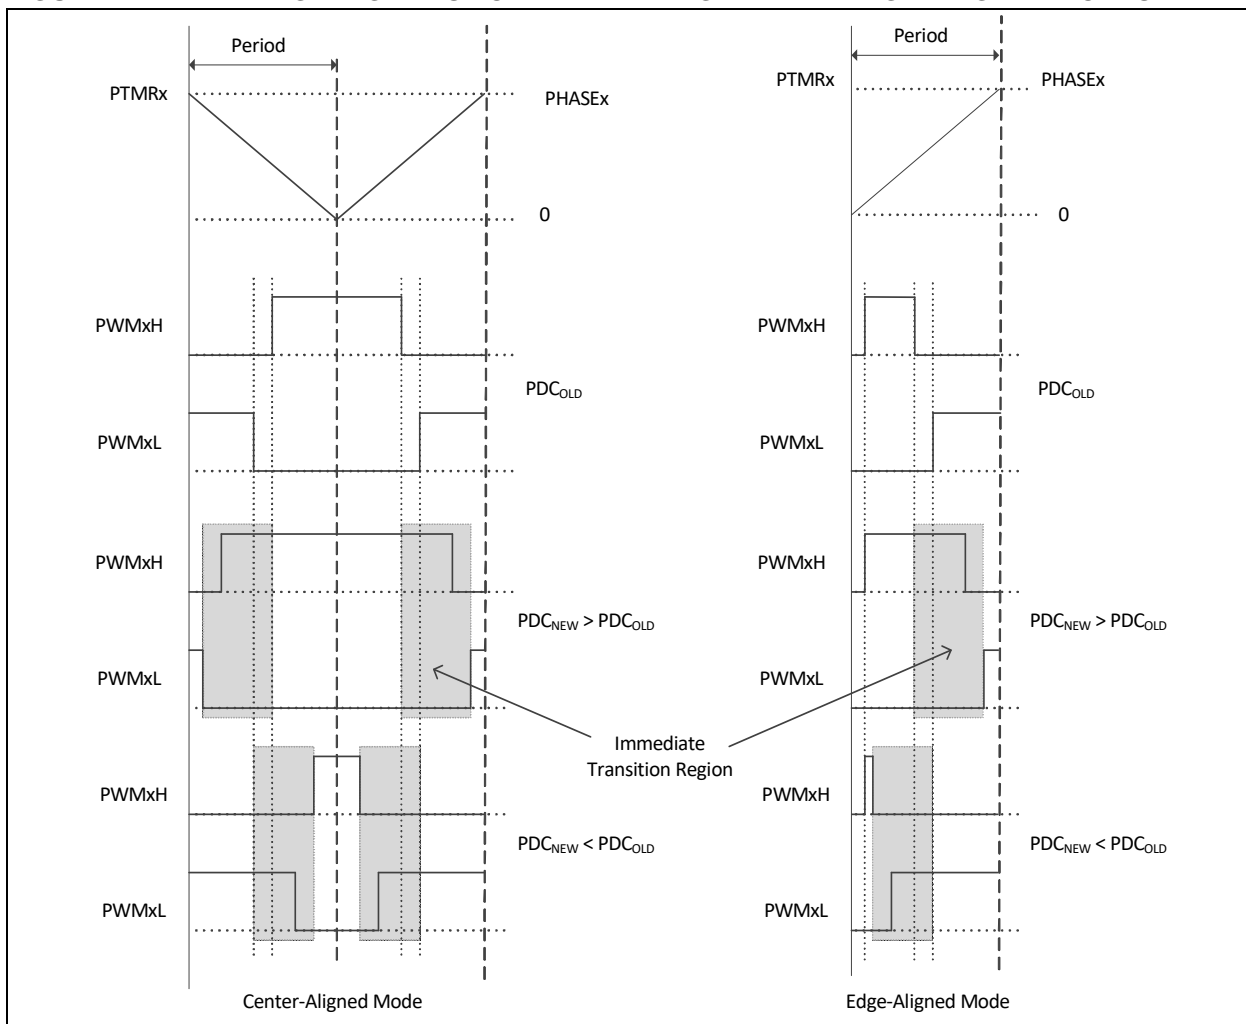
**FIGURE 1: TIMING DIAGRAMS FOR CENTER-ALIGNED AND EDGE-ALIGNED MODES**

The PWM generator may not assert dead time on the edges of transitions. This has been observed when all of the following conditions are present:

In **Figure 1**, if the duty cycle write occurred in the shaded box, then PWMxH and PWMxL will make an immediate transition without dead time.

None.

In most applications, the duty cycle update timing can be controlled using the TRIGx trigger, or Special Event Trigger, such that the above mentioned conditions are avoided altogether.

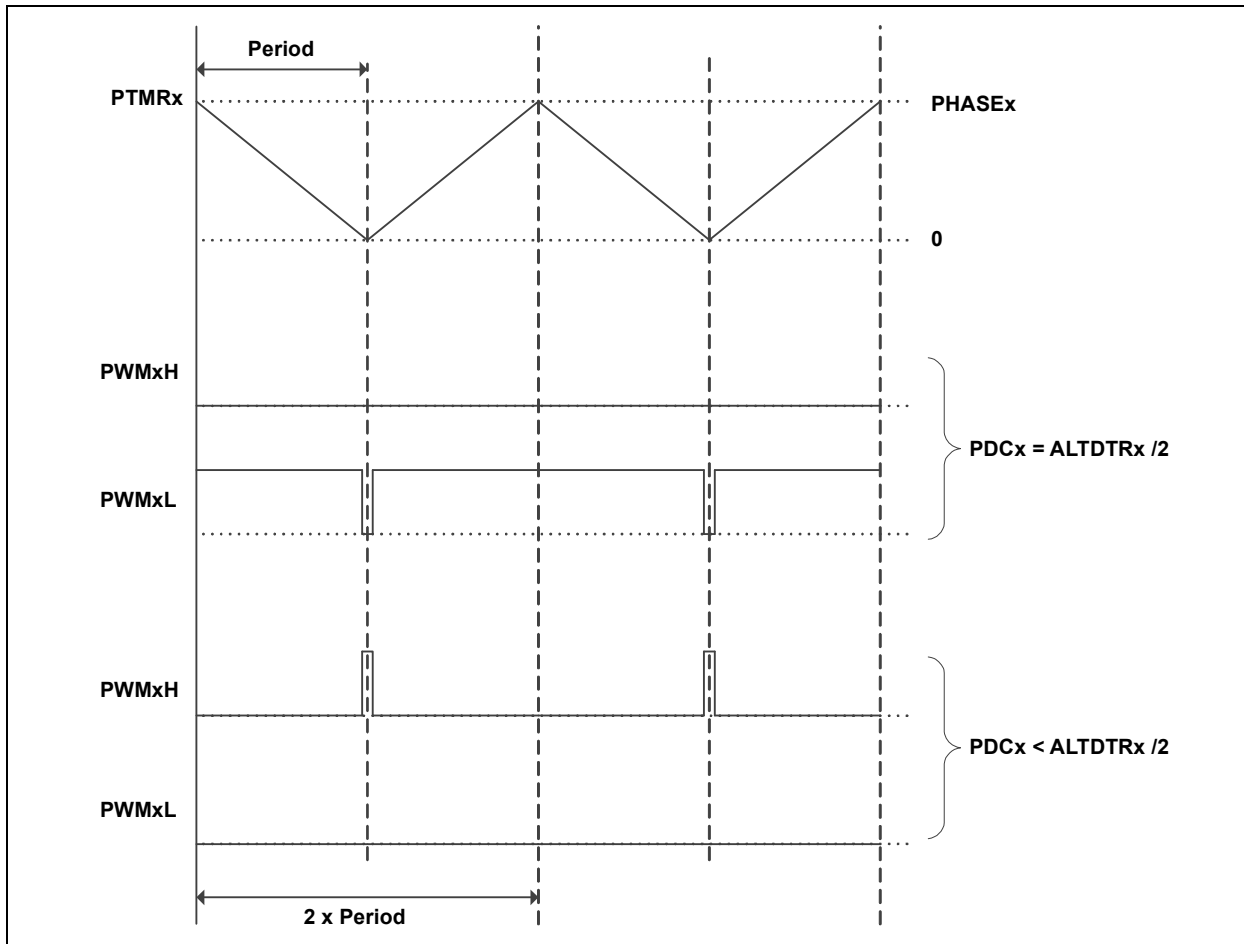
**FIGURE 2: PWM GENERATOR TIMING DIAGRAM**

In Center-Aligned Complementary mode with Independent Time Base, if the value in the PDCx register is less than one-half the value in the ALTDTRx register, the PWM generator will force the PWMxL to low, and on the PWMxH, generates pulses of a width less than twice the dead time, as shown in Figure 2.

Include a software routine to ensure that the duty cycle value written to the PDCx register is at least one-half of the value in ALTDTRx. Example 1 shows one method, with PDCtemp representing the variable which has the value to be written to the PDCx register. Alternatively, for duty cycle values less than half the desired dead-time value, zero out the ALTDTRx register or dynamically reduce the value in the ALTDTRx register, such that ALTDTRx is always equal to  $2 * PDCx$ , as shown in Example 2.

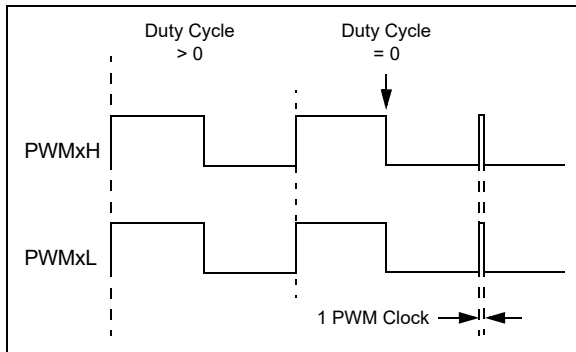
**FIGURE 3:**

In certain output modes, the PWMx module produces a pulse glitch of one PWM clock in width (Figure 3). This has been observed only when all of the following are true:

The pulse glitch has been observed to occur at the beginning of the following PWM boundary period.

If the application requires a duty cycle of zero, two possible work arounds are available.

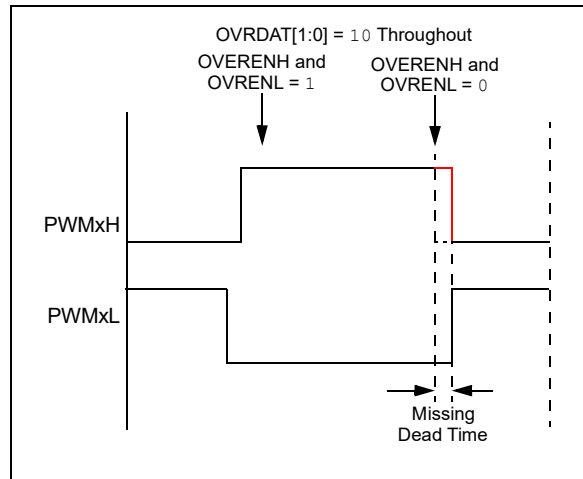
**FIGURE 4:**

This has been observed in both Center-Aligned and Edge-Aligned modes.

None.

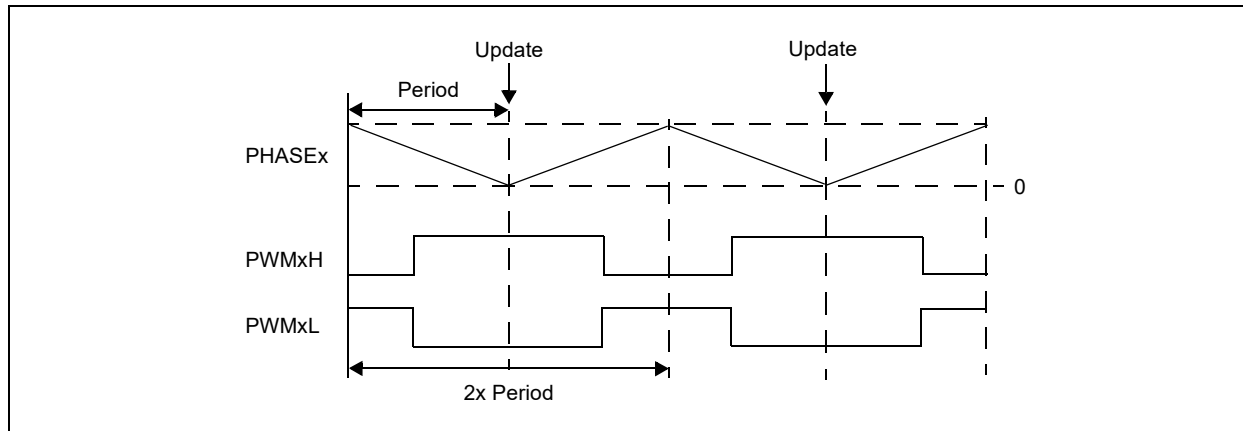
FIGURE 5:

In Center-Aligned Complementary mode with Independent Time Base, updates to the PHASEx register take effect in the middle of a Center-Aligned PWM cycle, as shown in Figure 5. This occurs only when the Immediate Update feature is disabled (IUE = 0). If Immediate Update is enabled (IUE = 1), the PHASEx register updates will take effect immediately.

None.

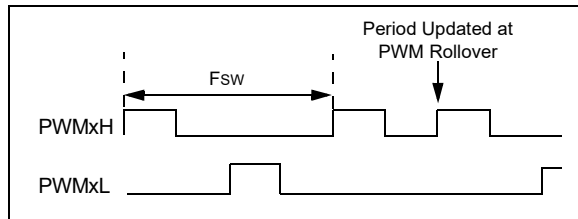
**FIGURE 6:**

When the PWM module is configured for Push-Pull mode (IOCONx[11:10] = 10) with the Enable Immediate Period Update bit enabled (PTCON[10] = 1), a write to the Period register that coincides with the period rollover event may cause the push-pull output logic to produce back-to-back pulses on the PWMx pins (Figure 6).

Ensure that the update to the PWM Period register occurs away from the PWM rollover event by setting the EIPU bit (PTCON[10] = 1). Use either the PWM Special Event Trigger (SEVTCMP) or the PWM Primary Trigger (TRIGx) to generate a PWM Interrupt Service Routine (ISR) near the start of the PWM cycle. This ISR will ensure that period writes do not occur near the PWM period rollover event.

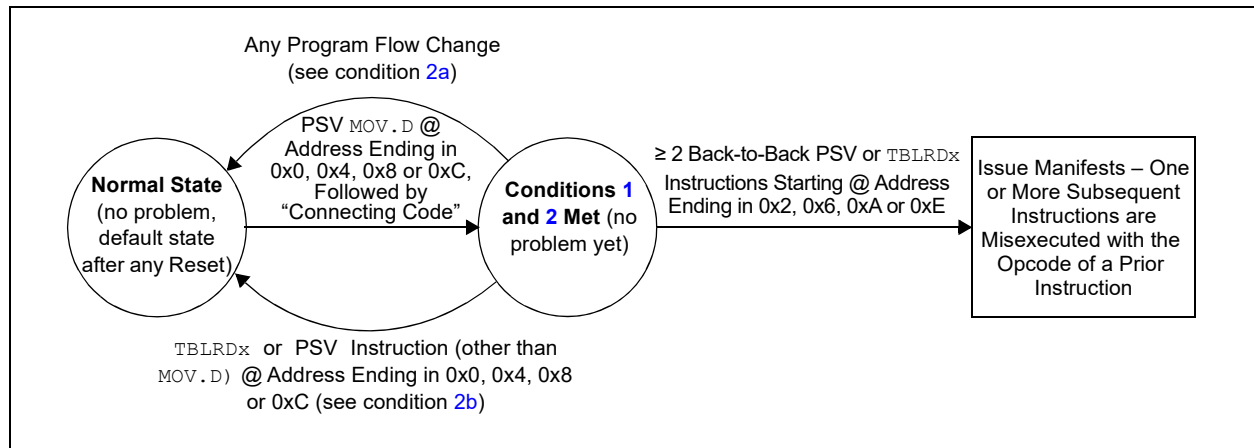
**FIGURE 7: SIMPLIFIED BEHAVIOR**

When two or more data Flash read instructions (via Program Space Visibility (PSV) read or table read) are executed back-to-back, one or more subsequent instructions can be misexecuted when all of the conditions in [Table 6](#) occur.

[Figure 7](#) provides an example of the effective behavior.

1. All instances of PSV `MOV.D` can be replaced with two PSV `MOV` instructions instead. Non-PSV `MOV.D` instructions acting on RAM/SFRs do not need to be modified; or
2. If not already present, a program flow change instruction (such as `BRA $+2`) can be inserted above back-to-back data Flash read sequences; or
3. Back-to-back data Flash read instruction sequences can be broken up by inserting a non-Flash read instruction (such as a `NOP`), in between the Flash read instructions; or
4. The alignment of the code can be shifted to avoid the required opcode location addresses.
