## Product Change Notification / SYST-18SFAM011

ERRATA - AVR128DA28/32/48/64 Silicon Errata and Data Sheet Clarification

## Silicon Errata and Data Sheet Clarification

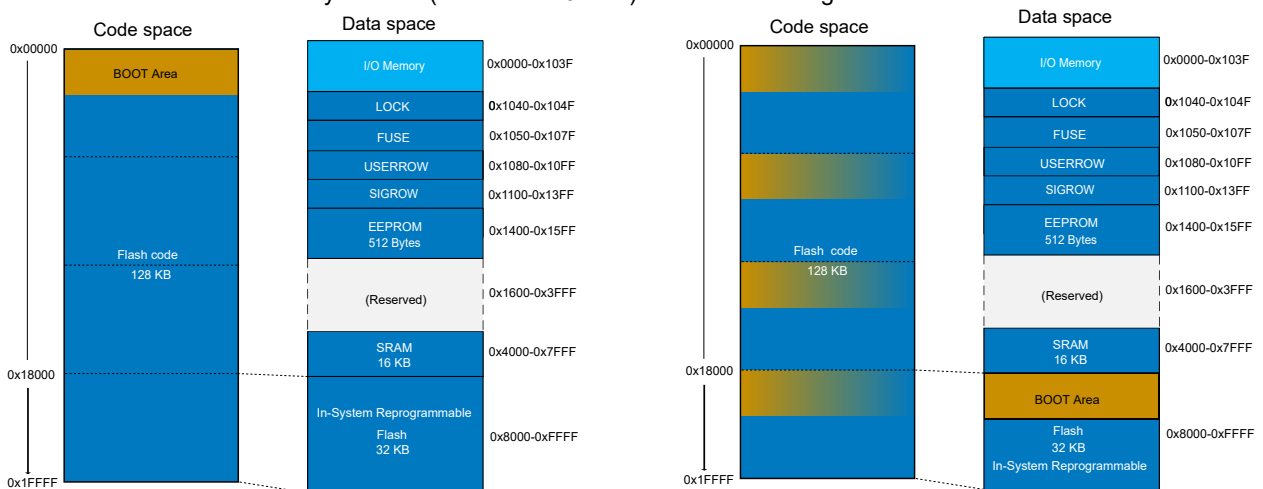
### 2.5.1 Flash Mapping Into Data Space not Working Properly

The inter-section Flash protection mechanism does not take into account the FLMAP bit field when checking if the address is in BOOT, APPCODE or APPDATA areas. It uses for comparison only the address offset between Flash start address in data space (0x8000) and the accessed address. This will cause the mirroring of the BOOT area in each Flash section selected by FLMAP (in blocks of 32 KB). Refer to the image below.

BOOT area for devices without issue

BOOT area for devices with issue

For read operations, the FLMAP bits work as documented when the Boot Read Protect (BOOTRP) bit is not enabled. For write operations, the inter-section Flash protection works properly only when FLMAP is set to '0x00'.

Use only store program memory (SPM) instructions to write and load program memory (LPM) instructions to read Flash memory.
