## Product Change Notification / SYST-30SUPV010

ERRATA - PIC32MK General Purpose and Motor Control (GPK/MCM) with CAN FD Family Silicon Errata

## PIC32MK General Purpose and Motor Control (GPK/MCM) with CAN FD Family Silicon Errata and Data Sheet Clarifications

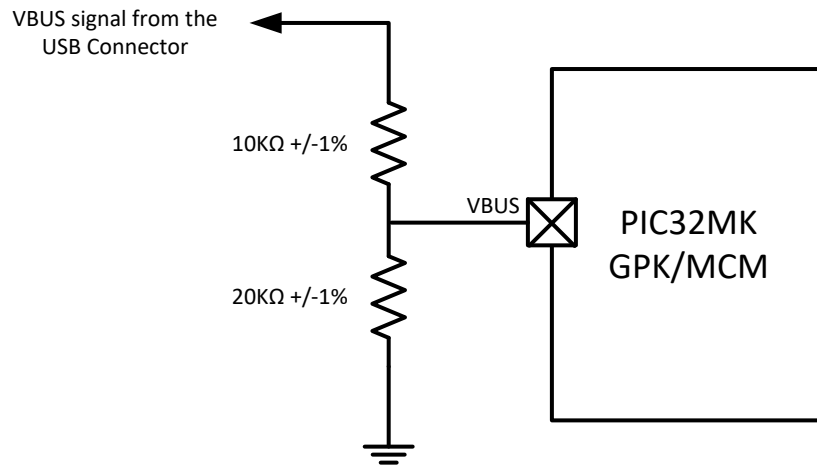
### 2.2.2 VBUS pin

The VBUS pin is not 5V tolerant.

Connect an external voltage divider as shown in the following figure:
