## Product Change Notification - SYST-05UUSH874

ERRATA - PIC18(L)F26/45/46K40 Family Silicon Errata and Data Sheet Clarification

## PIC18(L)F26/45/46K40 Family Silicon Errata and Data Sheet Clarification

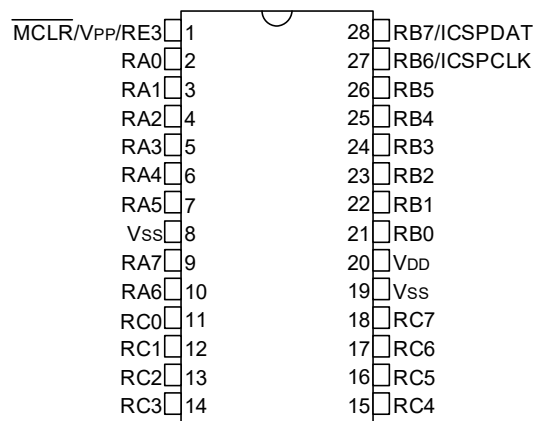
**Figure 1. 28-pin SPDIP, SSOP, SOIC**

The correct marking for pin 26 on the 28-pin SPDIP/SSOP/SOIC package is **RB5**.

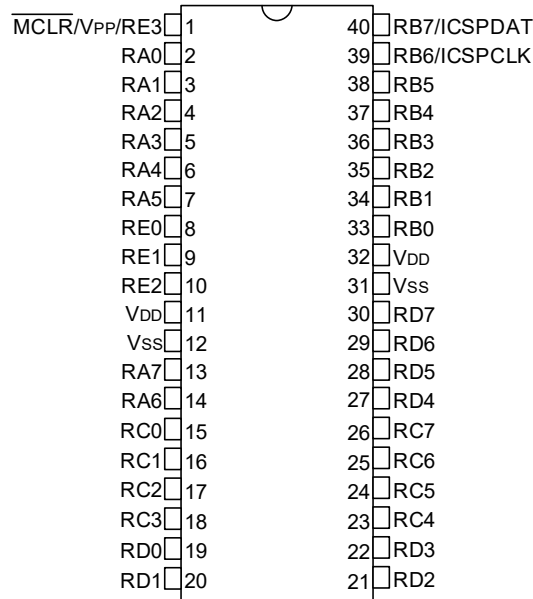
**Figure 3. 40-pin PDIP**

The correct marking for pin 38 on the 40-pin SPDIP package is **RB5**.

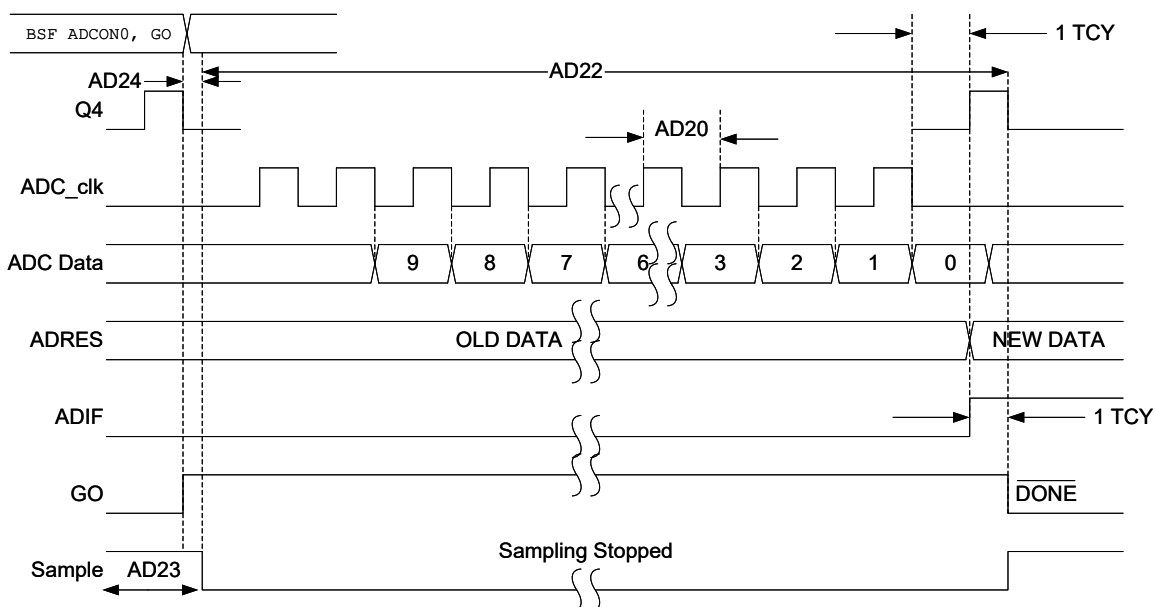
**Figure 38-10: ADC Conversion Timing (ADC Clock F<sub>OSC</sub>-Based)**

Refer to the images below for corrections of Figure 38-10 and Figure 38-11. Previously, the parameter numbers were incorrect.
