Product Change Notification - SYST-22TQTN001

ERRATA - AVR128DA28/32/48/64 Silicon Errata and Data Sheet Clarification Errata Document Revision

AVR128DA28/32/48/64

Silicon Errata and Data Sheet Clarification

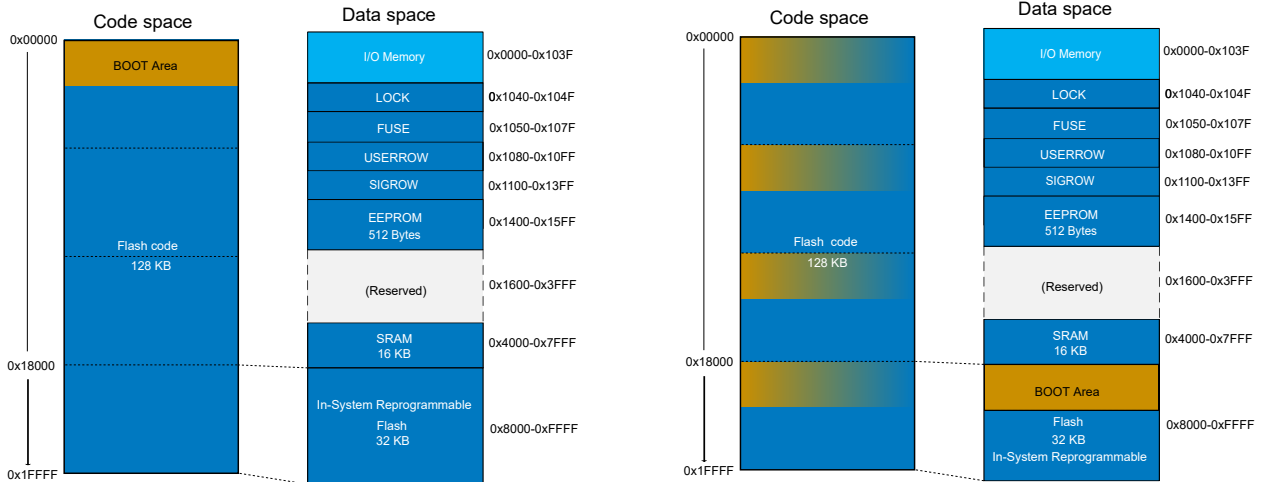
The inter-section Flash protection mechanism does not take into account the FLMAP bit field in the NVMCTRL.CTRLB register when checking if the address is in BOOT, APPCODE or APPDATA sections. It uses for comparison only the address offset between Flash start address in data space (0x8000) and the accessed address. This will cause the mirroring of the BOOT section in each Flash section selected by FLMAP (in blocks of 32 KB). See image below:

BOOT area for devices without issue

BOOT area for devices with issue

For read operations, the FLMAP bit field works as documented when the Boot Read Protect (BOOTRP) bit is not enabled.

For write operations, the inter-section Flash protection works properly only when FLMAP is set to 0x00.

Use only store program memory (SPM) instructions to write and load program memory (LPM) instructions to read Flash memory.
