Product Change Notification - SYST-08WVEY132

ERRATA - SAM G55 Series Family Silicon Errata and Data Sheet Clarifications

SAM G55 Series Family Silicon Errata and Data Sheet Clarification

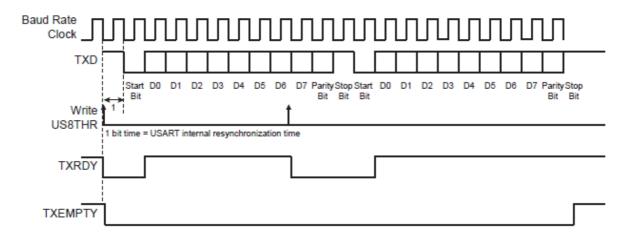
8. Module: USART - Transmitter Operations

Figure 30-6 is incorrect. The corrected figure is as shown below:
