## Product Change Notification / SYST-26RDCU841

ERRATA - PIC18(L)F26/45/46K40 Family Silicon Errata and Data Sheet Clarification

## PIC18(L)F26/45/46K40 Family Silicon Errata and Data Sheet Clarification

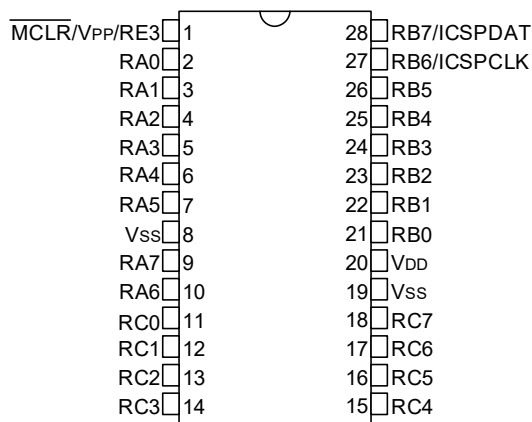
Figure 1. 28-pin SPDIP, SSOP, SOIC

The correct marking for pin 26 on the 28-pin SPDIP/SSOP/SOIC package is **RB5**.

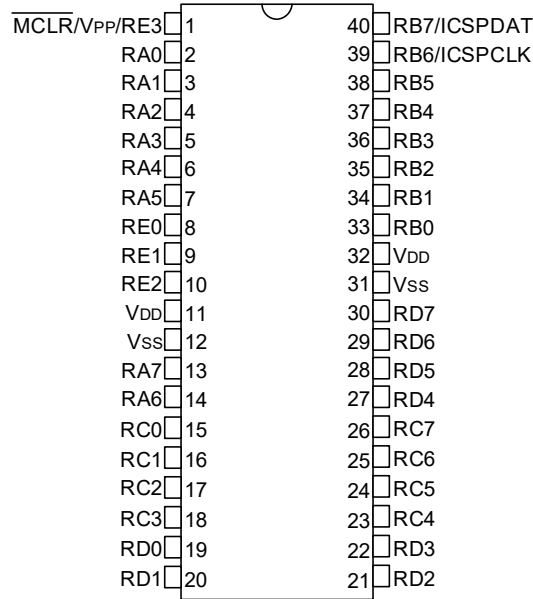
Figure 3. 40-pin PDIP

The correct marking for pin 38 on the 40-pin SPDIP package is **RB5**.

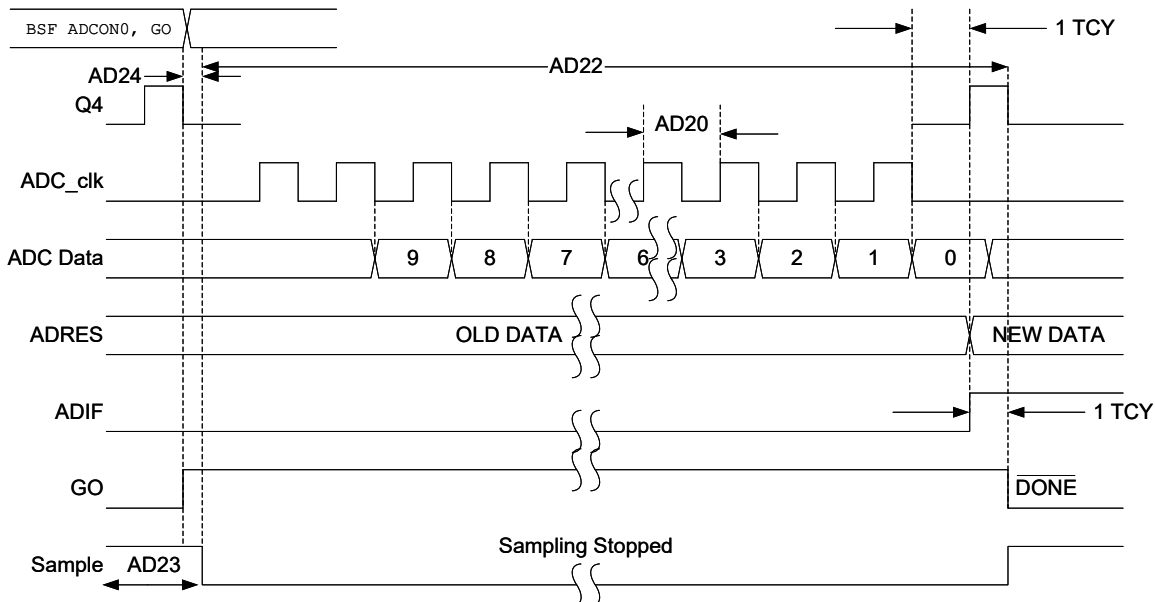
**Figure 38-10: ADC Conversion Timing (ADC Clock  $F_{OSC}$ -Based)**

Refer to the images below for corrections of Figure 38-10 and Figure 38-11. Previously, the parameter numbers were incorrect.
