Product Change Notification / SYST-28KSUP099

ERRATA - USB72x6/USB7252 Silicon Errata and Data Sheet Clarification Document Revision

USB72x6/USB7252 Silicon Errata and Data Sheet Clarification

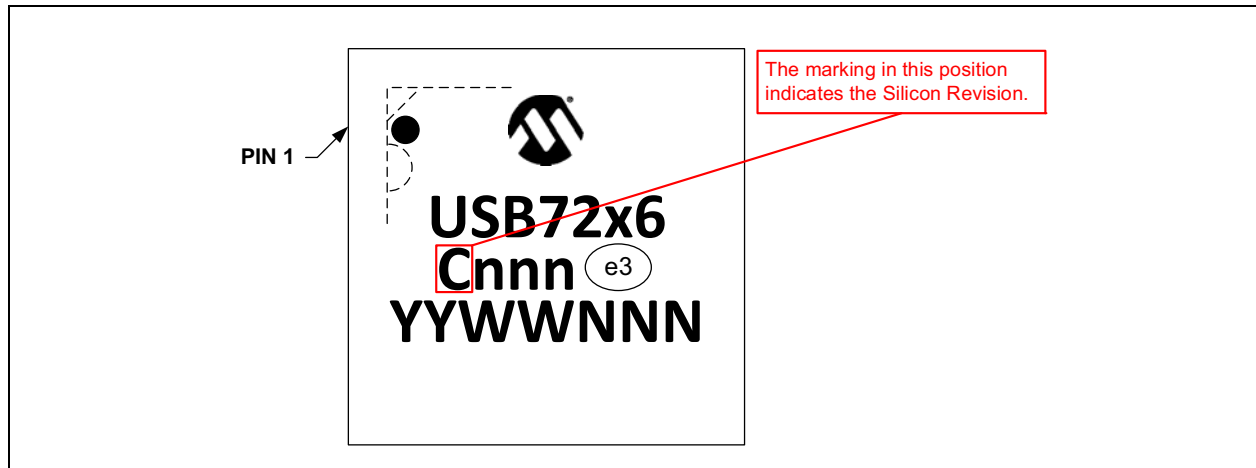
FIGURE 1: TOP MARKING SILICON REVISION INDICATION

The silicon errata discussed in this document are for silicon revisions as listed in [Table 1](#). The silicon revision can be determined by the device's top marking as indicated in [Figure 1](#). A summary of USB72x6/USB7252 silicon errata is provided in [Table 2](#).

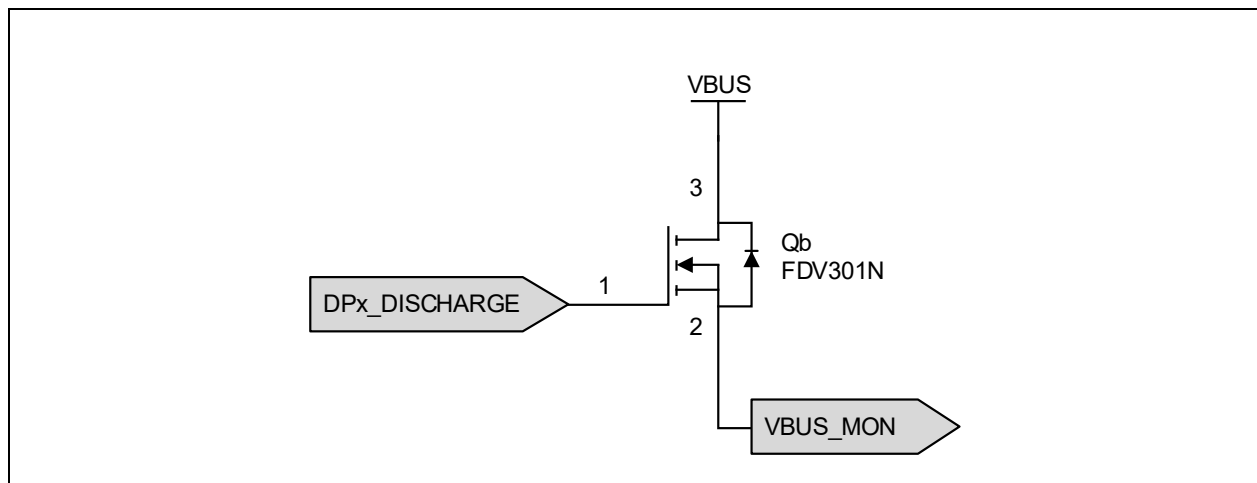
FIGURE 2: TYPE-C DISCHARGE WORKAROUND FOR MODULE 3

One requirement for USB-IF compliance certification of a system with an exposed Type-C port is the *Port Power On/Off* test. This test is part of the HUBCV suite of *Command Verification* tests for USB 2 devices. As part of this test, the hub must discharge VBUS, and then energize VBUS in response to CLEAR_FEATURE and SET_FEATURE commands from the test host.

Frequently, these ports will be implemented with electrolytic VBUS load capacitors, which retain a small residual charge that is released slowly compared to the timing of the discharge. In such cases, as energy is released from the capacitor the voltage can drift upward slightly after the discharge, which can cross the VBUS_DET threshold for detecting VBUS high. In the sequence of the Port Power On/Off test, this can inhibit subsequent turning on of VBUS in response to commands from the test host and the test fails.

Type C ports that have a large electrolytic capacitor may require this workaround to pass the HUBCV Port Power On/Off test.

In reference designs for USB7216 and USB7252 devices, an N-channel MOSFET with a V_{GS} less than 1.0V is connected between VBUS and VBUS_MON, with gate control from the DISCHARGE signal. This additional component creates an additional current path as the discharge is monitored by VBUS_MON, which biases VBUS_MON higher. This results in discharge to a lower voltage than what is otherwise achieved, and compensates for any residual energy that the capacitor releases after the discharge. At times other than the discharge, the MOSFET is turned off and does not influence VBUS.

No components of the reference design need to be removed; only the MOSFET is added.
