## Product Change Notification - SYST-08UUHO160

ERRATA - dsPIC33CH128MP508 Family Silicon Errata and Datasheet Clarification

## dsPIC33CH128MP508 Family Silicon Errata and Data Sheet Clarification

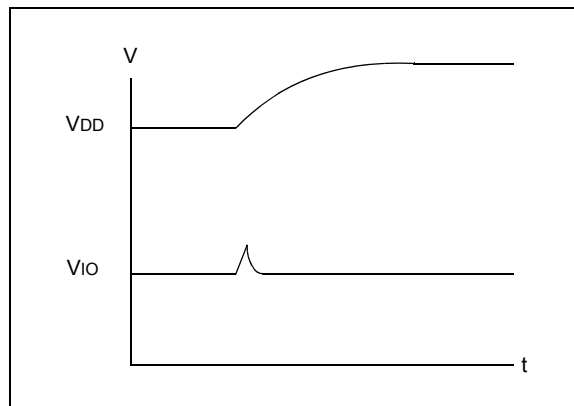
FIGURE 1: I/O RAMP

During a fast device power-up, when the V<sub>DD</sub> ramp is less than 4 mS, the I/O pins may drive up to 100  $\mu$ A current for a duration of up to 10  $\mu$ S (Figure 1).

Example applications affected may include complementary power switches, where a transient current shoot-through might occur.

1. Slow down the V<sub>DD</sub> ramp time (greater than 4 mS for V<sub>DD</sub> to ramp 0V to 3.3V).
2. Ensure the circuitry that is connected to the pins can endure this pulse.

High-voltage applications with complementary switches should power the high-voltage 200  $\mu$ Sec later than powering the dsPIC<sup>®</sup> device to avoid the current shoot-through. This behavior is specific to each device and not affected by aging.
