PIC32MK General Purpose and Motor Control (GP/MC) Silicon Errata and Data Sheet Clarification

The PIC32MK General Purpose and Motor Control (GP/MC) family of devices that you have received conform functionally to the current Device Data Sheet (DS60001402D), except for the anomalies described in this document.

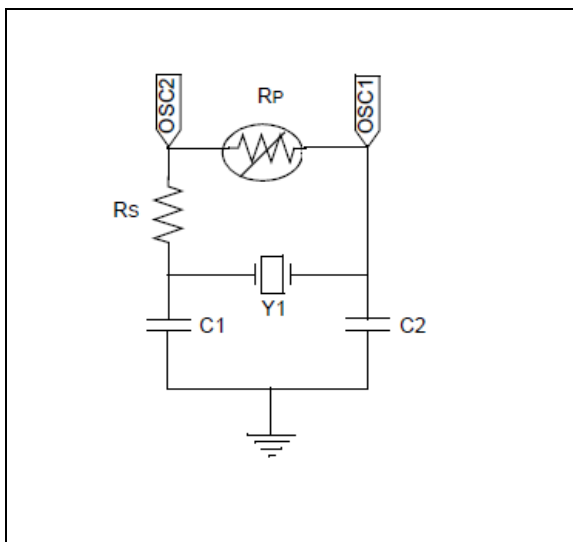
FIGURE 1: POSC CRYSTAL CIRCUIT

The POSC supports only specific crystal operation, as provided in [Table 3](#).

The Primary Oscillator (POSC) has been characterized to operate at 8 MHz and 12 MHz when the circuit shown in [Figure 1](#) is implemented and the operating conditions provided in [Table 3](#) are met.

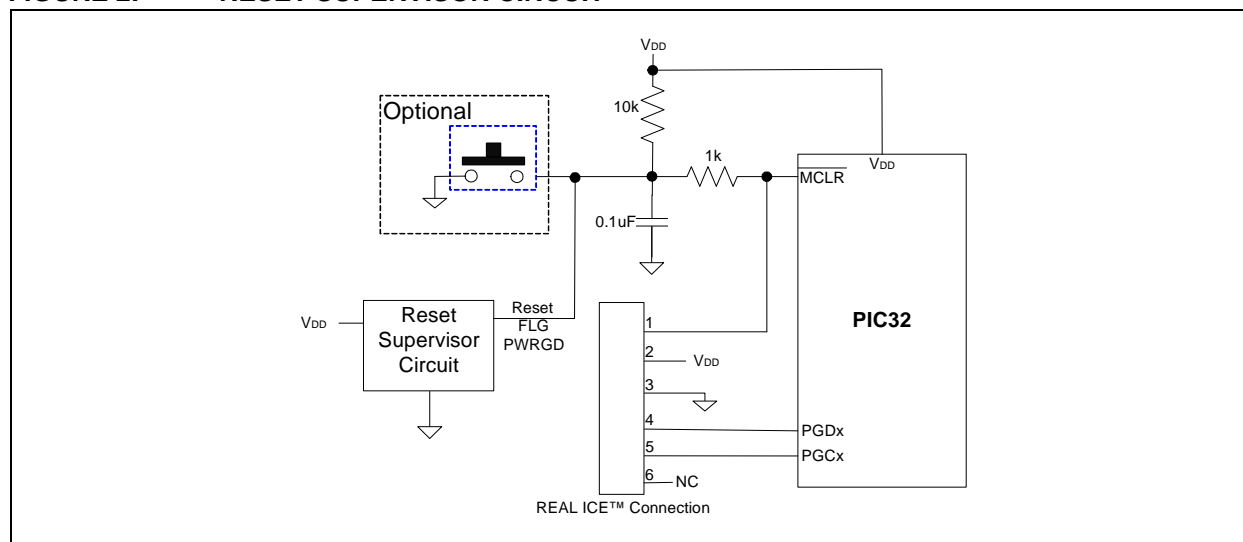
FIGURE 2: RESET SUPERVISOR CIRCUIT

On a BOR event, $V_{POR} < V_{DD} < V_{BOR}$, a reset is not generated when the BOR threshold is reached. System clocks will stop with all I/O pins function frozen in their present state until either V_{DD} falls to V_{POR} or V_{DD} returns to above V_{BOR} . The user must assess if this V_{DD} brownout condition and the resulting frozen I/O pin state has an adverse effect on their application (UART, PWM, I/O, OC, etc..)

If the application can sustain frozen I/O states for $\sim 2.1ms$ (UART, CAN, I/O, etc..), then the application must enable Deep Sleep Watchdog Timer and Clock Fail Monitor, based on the details provided in [Table 5](#) and [Table 6](#). If implemented correctly, after $\sim 2.1ms$, a valid internal reset state is entered and the I/O pins are set to the device default reset state.
