Product Change Notification - SYST-23IRS0834

ERRATA - dsPIC33CH512MP508 Family Silicon Errata and Data Sheet Clarification

dsPIC33CH512MP508 Family Silicon Errata and Data Sheet Clarification

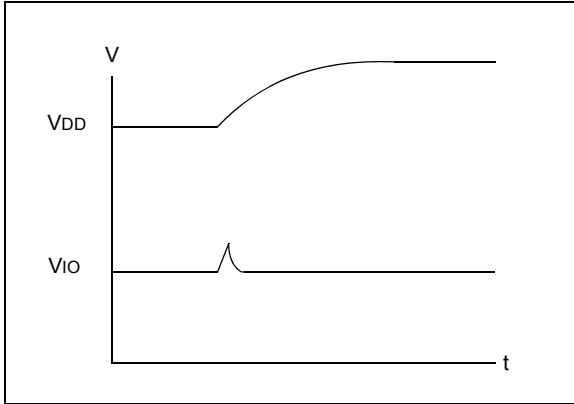
FIGURE 1-1: I/O RAMP

During a fast device power-up, when the VDD ramp is less than 4 mS, the I/O pins may drive up to 100 μ A current for a duration of up to 10 μ S (Figure 1-1).

Example applications affected may include complementary power switches, where a transient current shoot-through might occur. High-voltage applications with complementary switches should power the high-voltage 200 μ Sec later than powering the dsPIC[®] device to avoid the current shoot-through. This behavior is specific to each device and not affected by aging.

1. Slow down the VDD ramp time (greater than 4 mS for VDD to ramp 0V to 3.3V).
2. Ensure the circuitry that is connected to the pins can endure this pulse.
