Product Change Notification / SYST-31TCNJ739

ERRATA - PIC18F27/47K40 Family Silicon Errata and Data Sheet Clarification

PIC18(L)F27/47K40 Family Silicon Errata and Data Sheet Clarifications

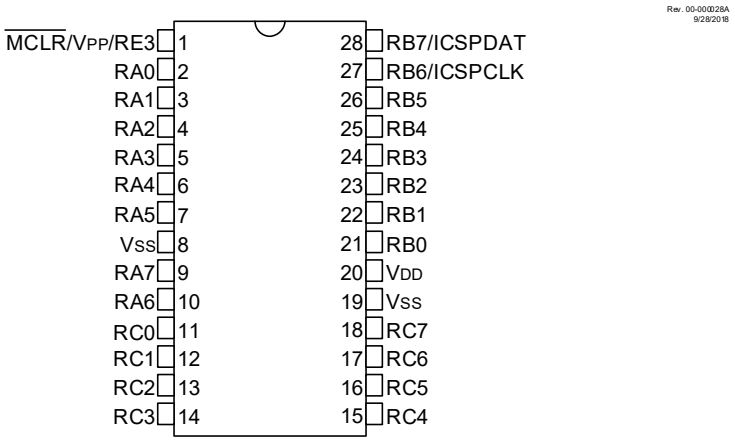
Figure 1. 28-pin SPDIP, SSOP, SOIC

The correct marking for pin 26 on the 28-pin SPDIP/SSOP/SOIC package is **RB5.**

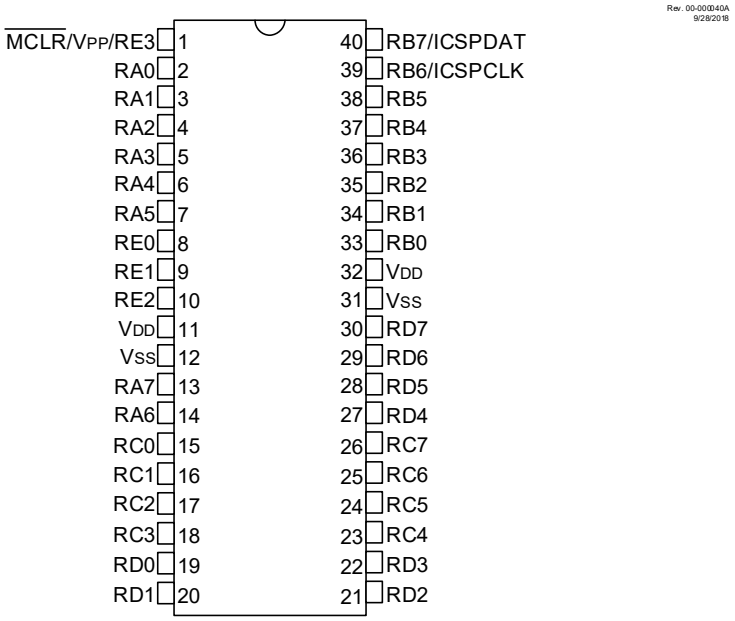
Figure 3. 40-pin PDIP

The correct marking for pin 38 on the 40-pin SPDIP package is **RB5.**

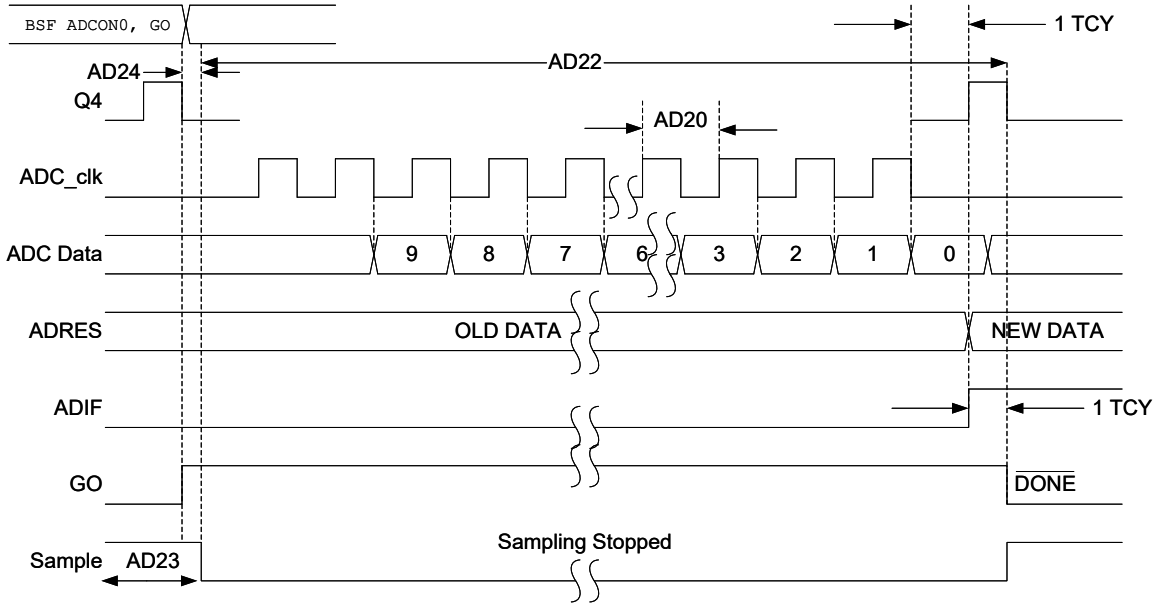
Figure 38-10: ADC Conversion Timing (ADC Clock F_{OSC}-Based)

Refer to the images below for corrections of Figure 38-10 and Figure 38-11. Previously, the parameter numbers were incorrect.
