Product Change Notification - SYST-24DUVO623

ERRATA - PIC24FJ128GA310 Family Errata

Description of Change: Added silicon issue 15

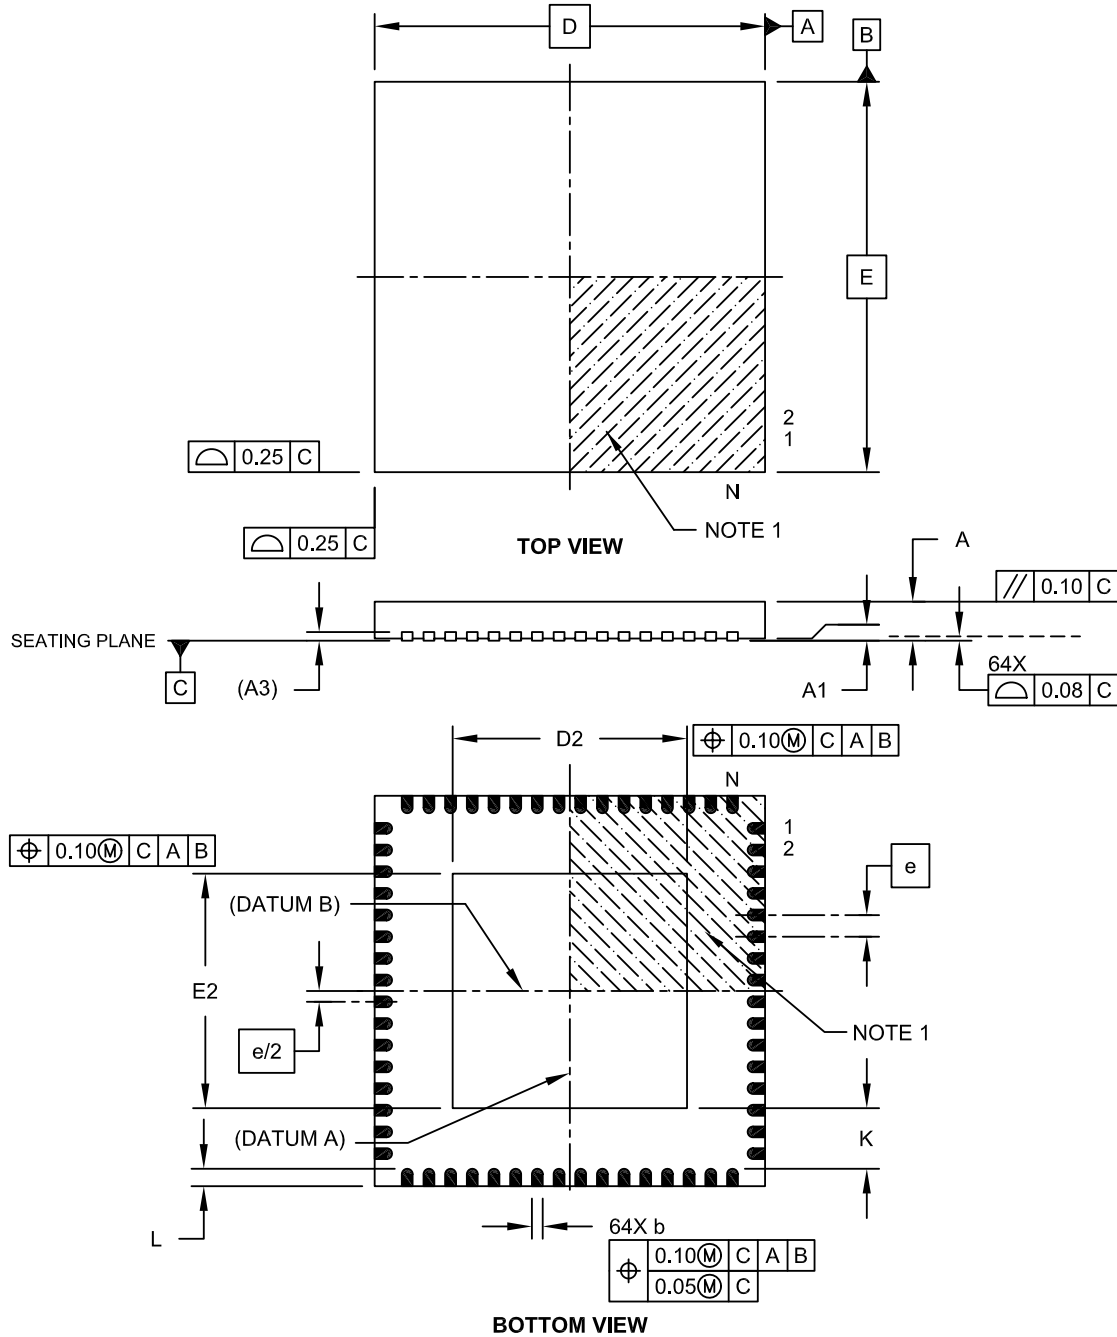
64-Lead Plastic Quad Flat, No Lead Package (MR) – 9x9x0.9 mm Body with 5.40 x 5.40 Exposed Pad [QFN]

The 64-Lead Plastic Quad Flat, No Lead Package (MR) drawings on Pages 391 through 393 have been replaced with the C04-154A package drawings shown below.

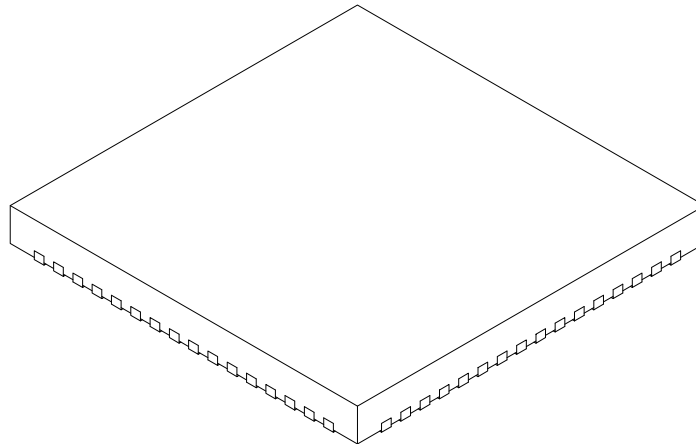
64-Lead Plastic Quad Flat, No Lead Package (MR) – 9x9x0.9 mm Body with 5.40 x 5.40 Exposed Pad [QFN]

Units		MILLIMETERS		
Dimension Limits		MIN	NOM	MAX
Number of Pins	N	64		
Pitch	e	0.50 BSC		
Overall Height	A	0.80	0.90	1.00
Standoff	A1	0.00	0.02	0.05
Contact Thickness	A3	0.20 REF		
Overall Width	E	9.00 BSC		
Exposed Pad Width	E2	5.30	5.40	5.50
Overall Length	D	9.00 BSC		
Exposed Pad Length	D2	5.30	5.40	5.50
Contact Width	b	0.20	0.25	0.30
Contact Length	L	0.30	0.40	0.50
Contact-to-Exposed Pad	K	0.20	-	-

1. Pin 1 visual index feature may vary, but must be located within the hatched area.
2. Package is saw singulated.
3. Dimensioning and tolerancing per ASME Y14.5M.
