Handwheels • DIN 950 light metal

24590.0221

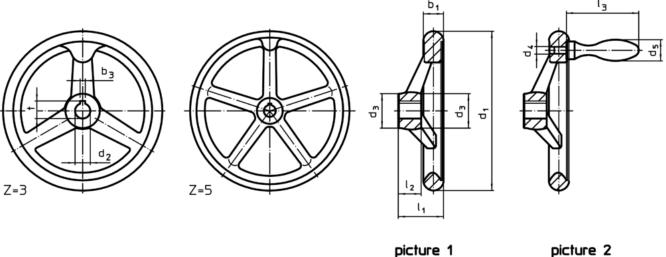
Drawing

The orientation of the hub keyway may be different than shown in the drawing.

picture 2

| Dimensions | | | | | | | | Number of spokes | Corresponding machine handle | Ĭ | Art. No. |
|---|---|---|---|---|---|---|---|---|---|---|---|
| without keyway, with rotating handle EH 24460., assembled form B-F/G (formerly D 4) – picture 2 | | | | | | | | | | | |

| Dimensions | | | | | | | | Number of spokes | Corresponding machine handle | Ĭ | Art. No. |
|---|---|---|---|---|---|---|---|---|---|---|---|
| 160 | 16 | 32 | M10 | 25 | 40 | 20 | 75 | 3 | 25 | 615 | 24590.0221 |
